# **FACILITIES ASSESSMENT**

## **CITY OF WAUKEGAN**

January 3rd, 2018  
Project #: 1709

**RE: Facility Assessment - Synopsis**

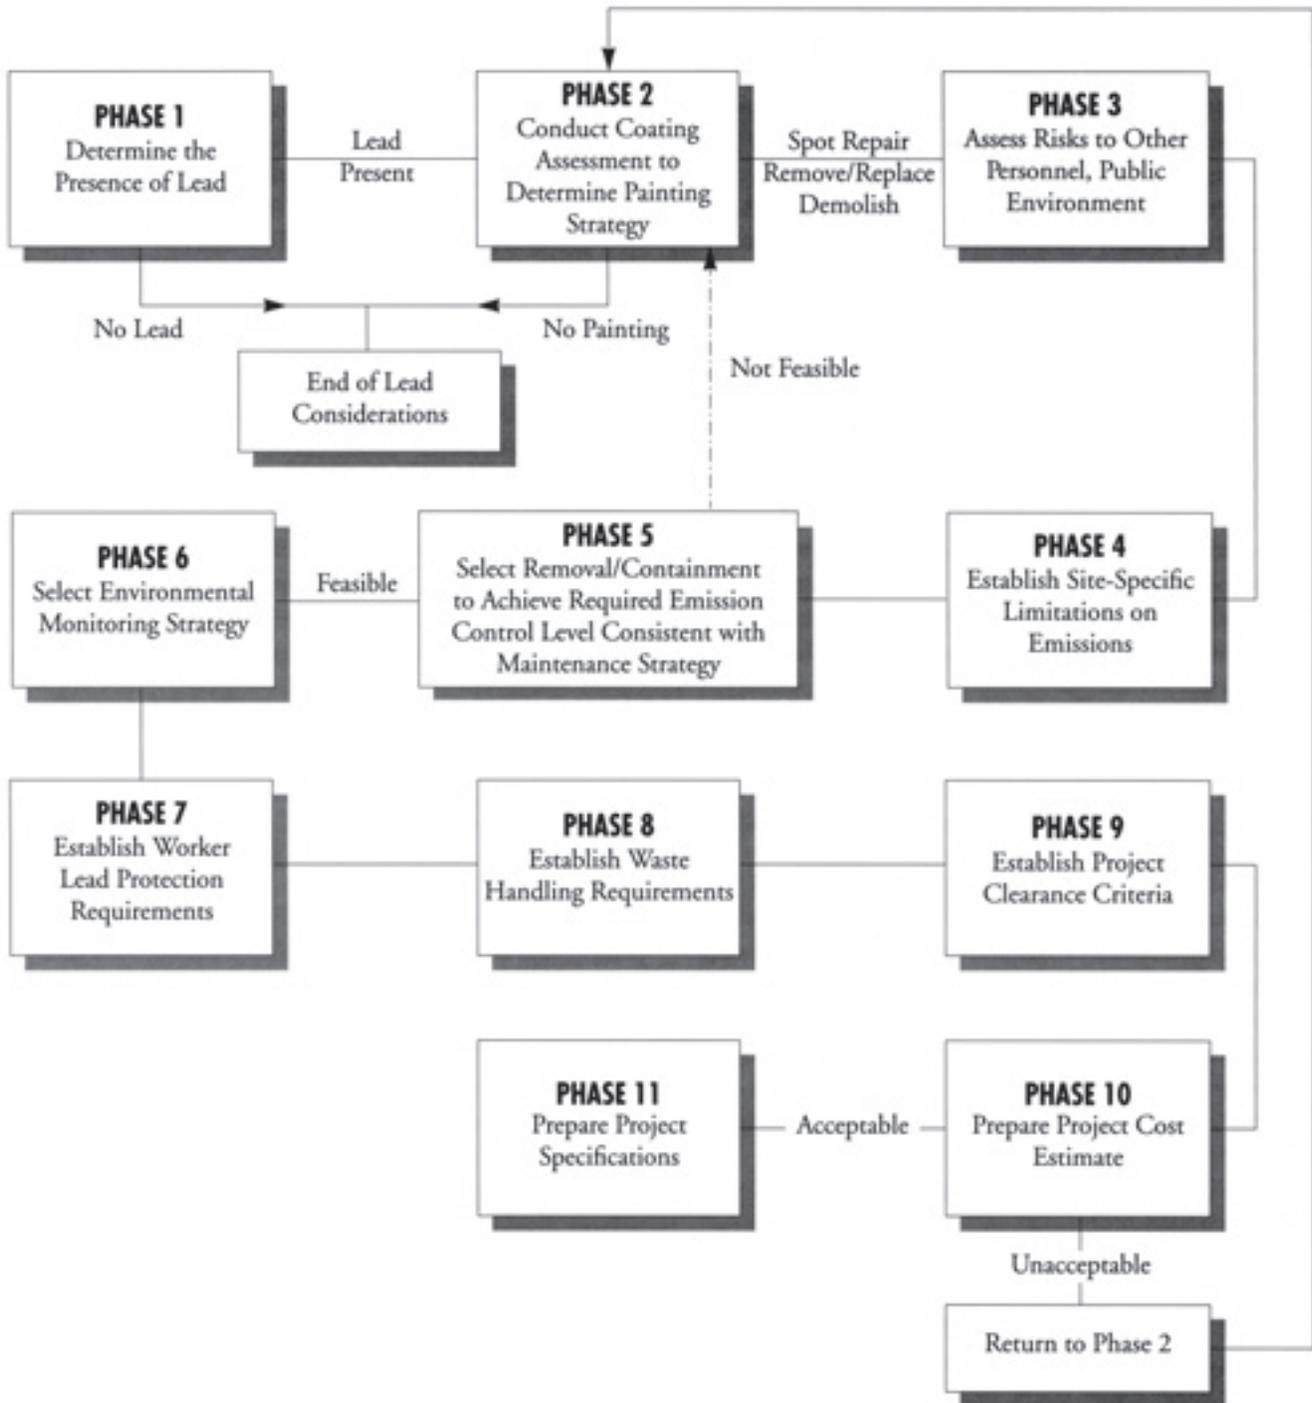
## Appendix A—Design Path for Project Design—Industrial Lead Paint Management

This flow chart is reproduced with permission from "Project Design, Industrial Lead Paint Removal Handbook, Volume II," published in 1994 by Technology Publishing Co.
